Manejo de humedales para técnicos en México

**USANDO INFORMACIÓN ABIÓTICA
COMO FUNDAMENTO PARA LOGRAR UN
EFECTIVO MANEJO Y RESTAURACIÓN
DE HUMEDALES**

Hydrogeomorphic Evaluations

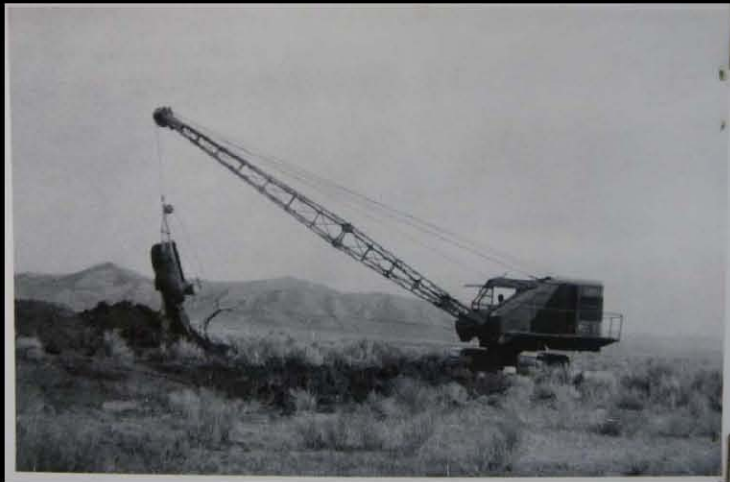
EARLY REFUGE MANAGEMENT

- Marsh “development” began in the 1950s
- Diked impoundments to hold water
- Collection ditch collected water discharged from springs
- Impoundments designed to hold STABLE water at FULL POOL throughout breeding season

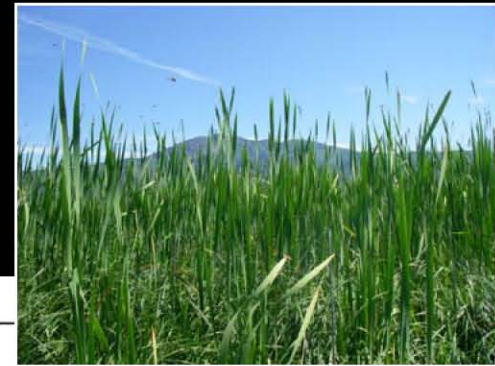
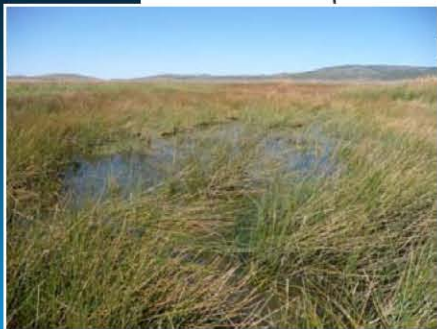
MODIFIED HYDROLOGY

- HIGHLY MODIFIED hydrology
 - Shortened hydroperiod
 - Stabilized summer water levels compared to historical
 - Natural drainage is “backwards”

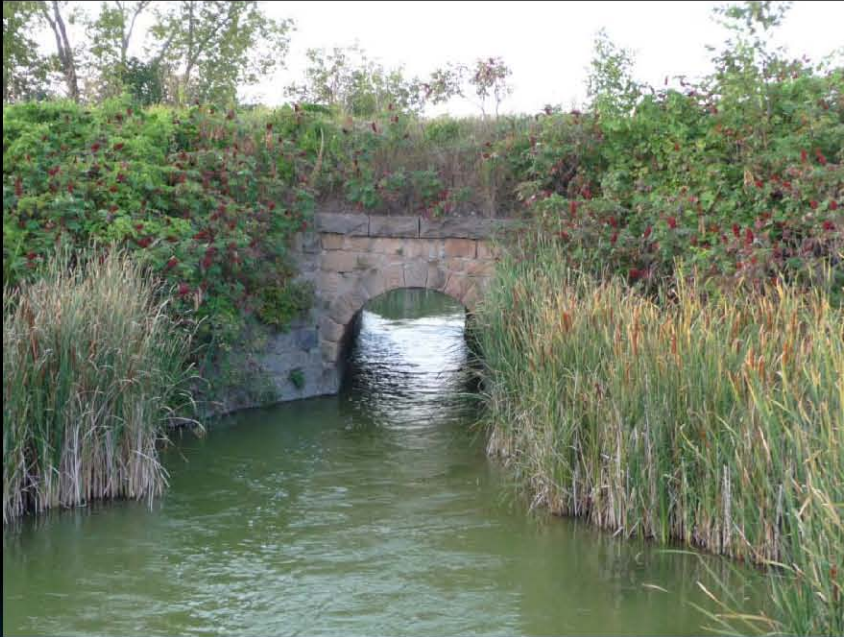
MODIFICATIONS

- Surrounding landscape not intensively farmed
- Railroad crossing “impounded” lake
- Highway also built across natural outlet
- Invasive species

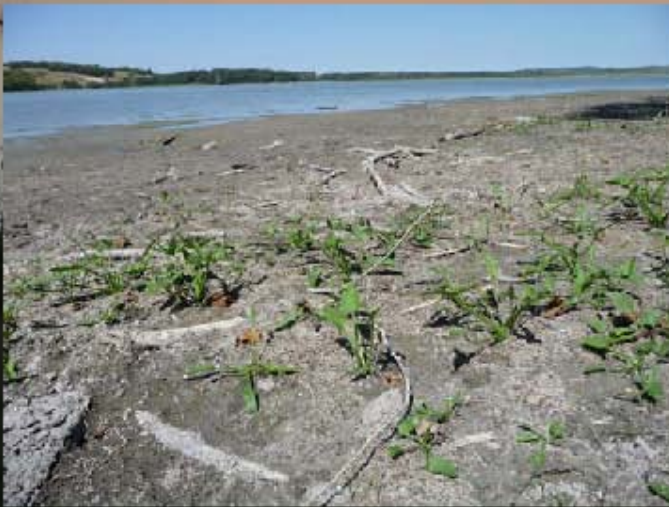
- Pump station with downstream aerator installed
 - ▣ Operation will be less expensive and less time consuming than rotenone treatments
 - ▣ Periodically lower lake water levels by 3 feet (e.g., when Chara is reduced to less than 50%)

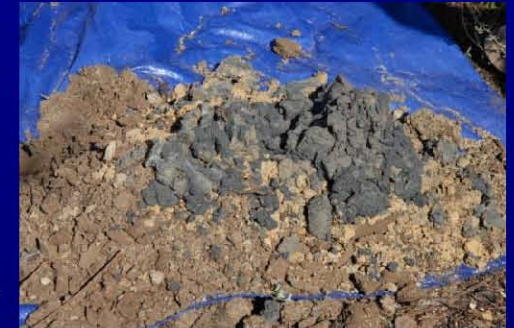
Generalized Soil Profile

Water Table
avg 40 in below surface
(range 24 – 58 in)

Clay Loam
range 16–58 in deep
avg 30 in deep

Sandy Clay Loam
or Silty Loam

Sandy
Loam

Silty Clay Loam or Clay
Calcium carbonate hard pan
